GYPSUM CONSTRUCTION TROUBLESHOOTING GUIDE GYPSUM BOARD

The purpose of this document is to serve as a guide for identifying common interior wall construction and finishing problems, list probable causes, typical corrective actions and tips for prevention.

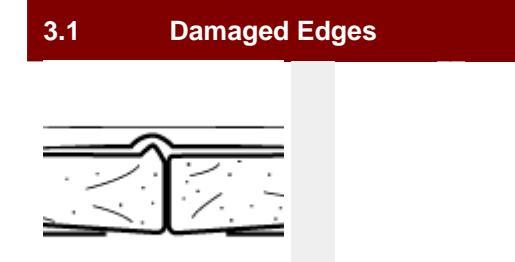
Fig. 1

Cause: Paper-bound edges have been damaged or abused; may result in ply separation along edge or in loosening of paper from gypsum core, or may fracture or powder the core itself. Damaged edges are more susceptible to ridging after joint treatment (Fig. 1).

Correction: Cut back any severely damaged edges to sound board before application.

Prevention: Avoid using board with damaged edges that may easily be compressed or can swell upon contact with moisture. Handle gypsum panels with reasonable care.
